Introduction

Free Flowing liquids within the Metal re-cycling process

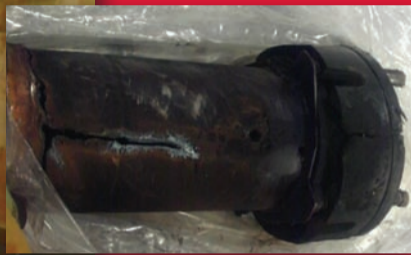
The Flashback reached a height of 3 metres

An incident recently occurred at the Studsvik Metal Recycling Facility when an item that had been delivered for treatment was being cut using a Plasma Arc cutting Torch.

A quantity of oil was released from a submersible pump which ignited and caused a flashback that reached a height of 3 metres. Luckily no one was injured.

There was no release of activity and the incident was classed as a near miss with a high potential to cause injury.

Free Flowing Liquids are not permissible within the MRF Waste Acceptance Criteria and should not be despatched by consignors. The recent incident within the MRF highlights the consequences of Flammable Free Flowing Liquid within the process.
