Introduction

Free Flowing liquids within the Metal re-cycling process

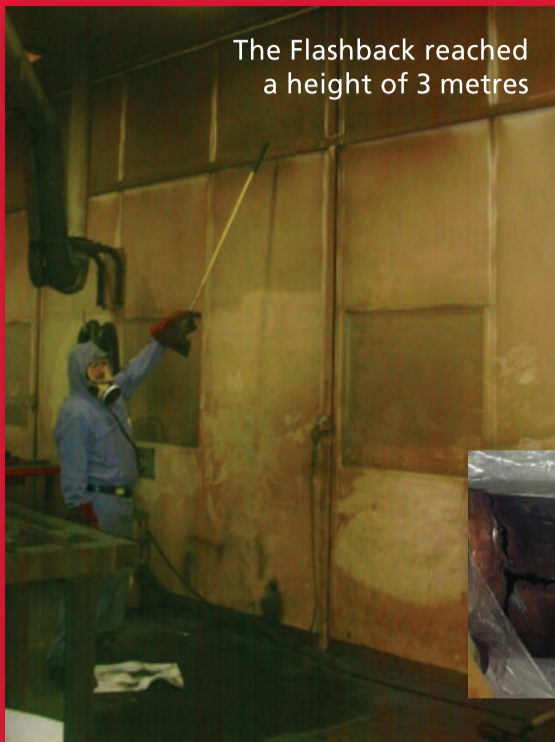
The Flashback reached a height of 3 metres

A quantity of oil was released from a submersible pump which ignited and caused a flashback that reached a height of 3 metres. Luckily no one was injured.

There was no release of activity and the incident was classed as a near miss with a high potential to cause injury.

Free Flowing Liquids are not permissible within the MRF Waste Acceptance Criteria and should not be despatched by consignors. The recent incident within the MRF highlights the consequences of Flammable Free Flowing Liquid within the process.

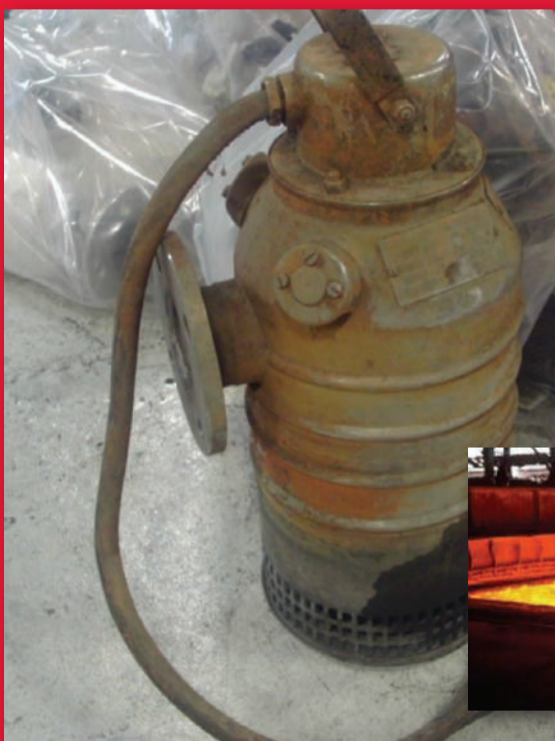
The purpose of this Safety Share is to highlight the hazards that Free Flowing Liquids present in the Metal recycling process (in both downsizing within the MRF and in Smelting at the Swedish plant) and to spread the learning to consigners of metal waste to the MRF.

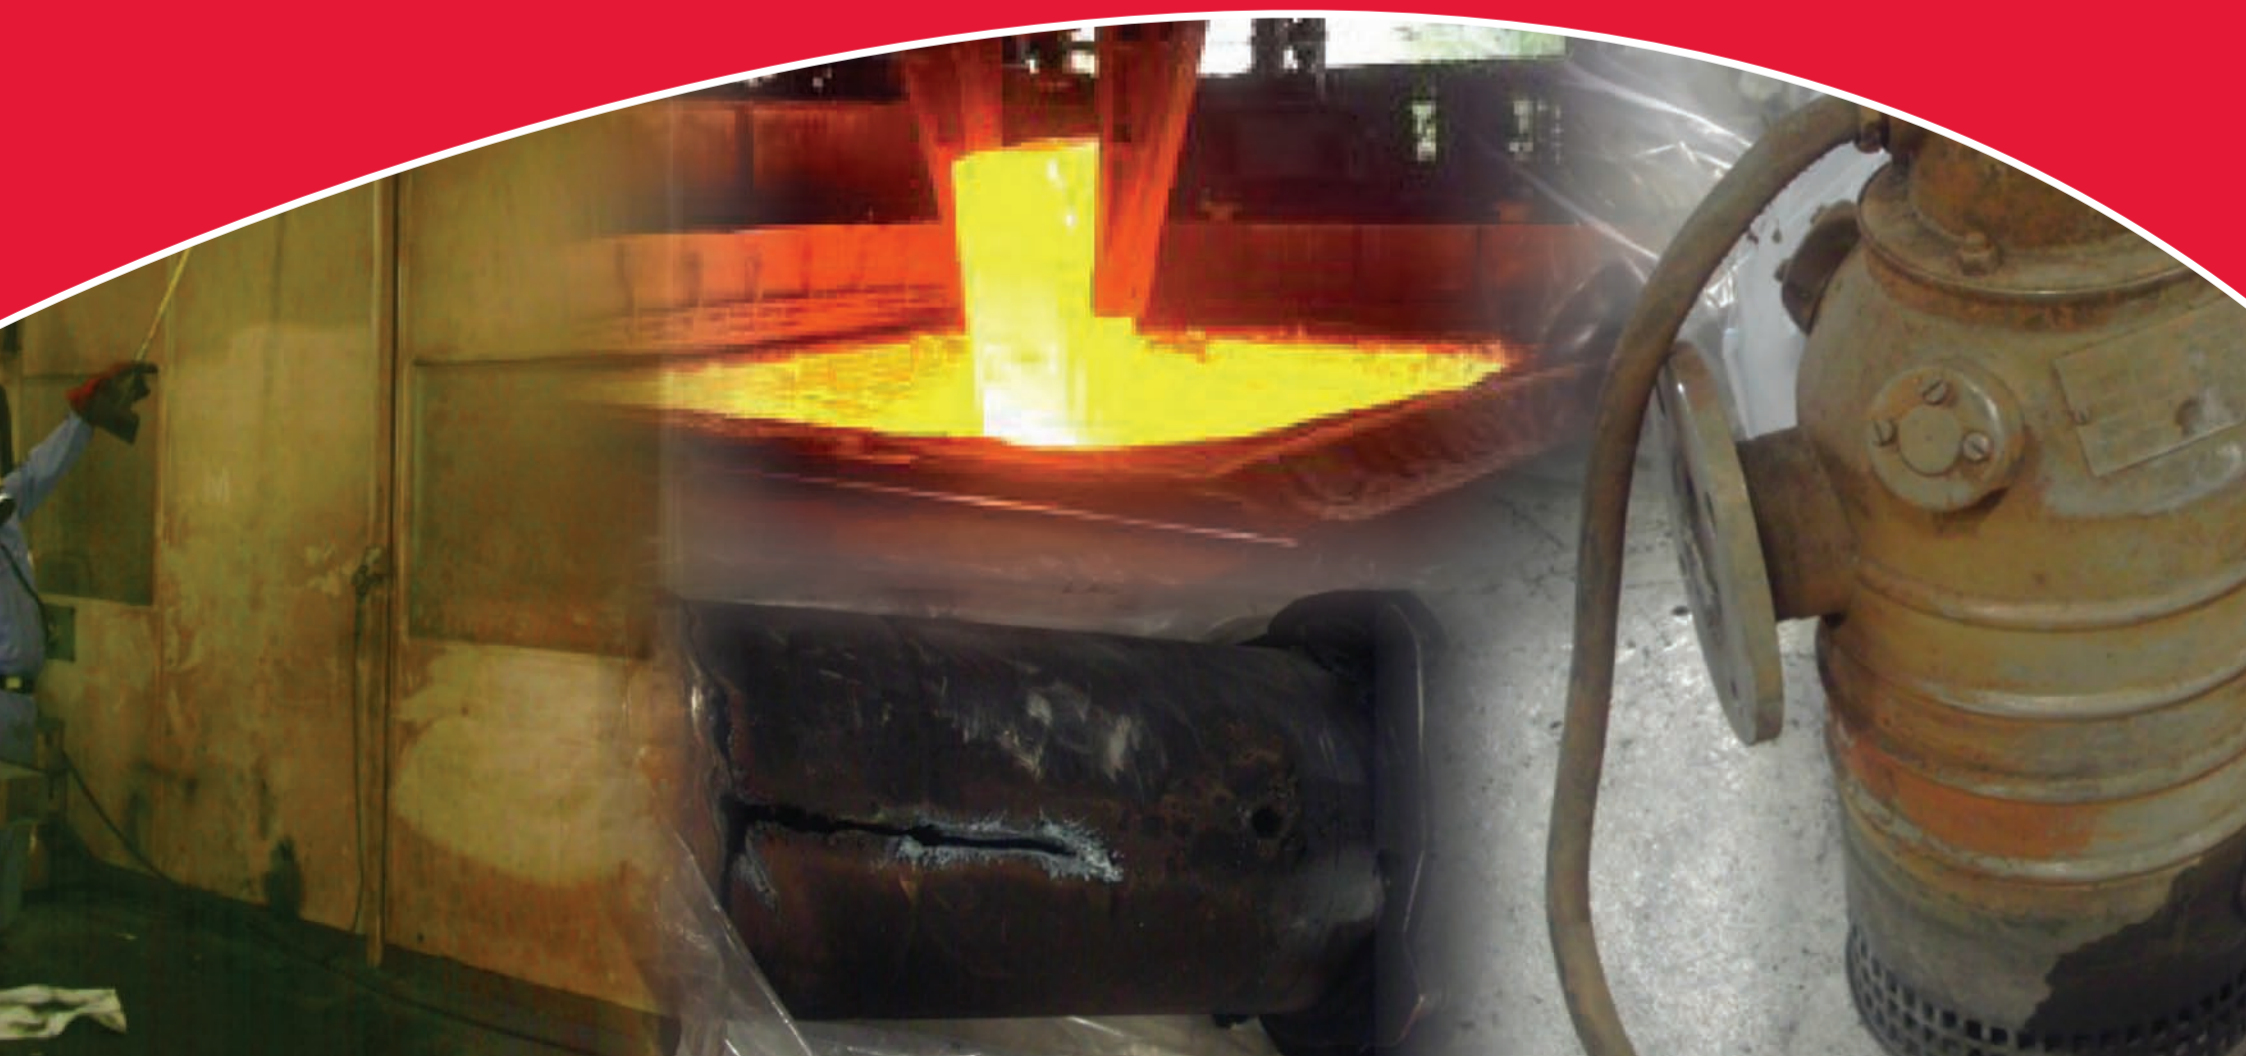
MARCOULE INCIDENT

Investigations into the recent incident at the Marcoule plant in France indicates that Free Flowing Liquid contained within a recycled object may have been the cause of molten metal being expelled from a Smelter resulting in the death of a worker.
